CHAPTER 3

## THE PRIORY BUILDINGS

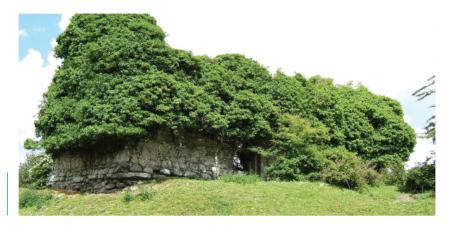
The Teampoilín, Poolboy.

The nearest church under their care was the little church in Poolboy, known as the Teampoilín, the ruins of which are still standing. To provide easy access to this church, the Canons laid

down a pathway across Kellysgrove bog, directly connecting Clontuskert Priory with the Teampoilín and other places where they ministered in the general Ballinasloe area. The remains of this walkway or togher, once known as the 'Monks' Pass' were discovered in 1946 during a major bog-drainage operation. This is dealt with in Chapter 4.

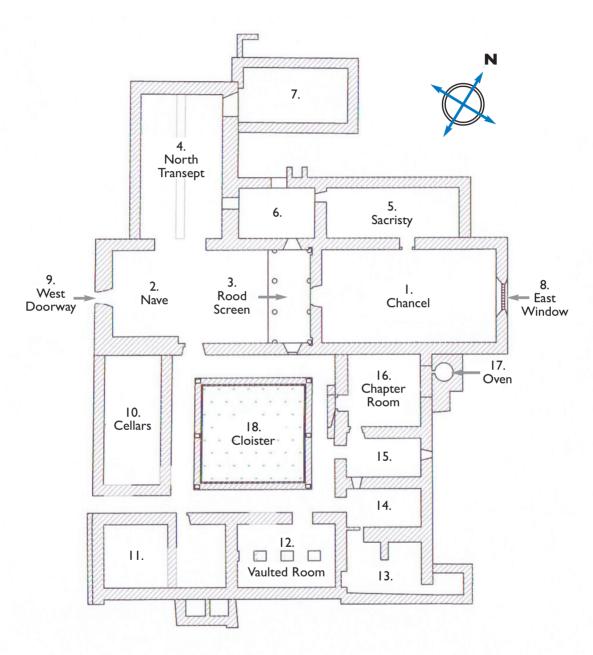
Floor Plan of Priory Buildings [Drawn by John Tully, Lismanny]

When the preparatory excavation work of 1971-72 was completed, the outline of the church and the area where the canons lived became easier to discern. The main structure of the priory, stretching from the west doorway to the east window, is divided in almost equal sections by a wall, in the centre of which is a connecting doorway. The section containing the east window is known as the chancel, while the other section adjacent to the west doorway is the nave. The wall which divides the chancel from the nave is a late addition to the building. At one time, before the building of the dividing wall, the nave and chancel were separated only by a rood screen. Built at right angles to the nave is the north transept with its simple north-facing window.

# THE CHANCEL (Floor Plan 1)

# THE NAVE (Floor Plan 2)

## THE WEST DOORWAY (Floor Plan 9)

# THE NORTH TRANSEPT (Floor Plan 4)

The central area of the domestic buildings was centred on the Cloister Garth. (*Floor Plan 18*) This was a small garden open to the sky, on the four sides of which was an ambulatory or veranda covered by a lean-to roof, where the canons strolled during their recreation periods each day, irrespective of the exigencies of the weather. Much of this cloister was unearthed during the 1972 excavations and faithfully reconstructed. On each side of the Cloister Garth was a row of ten arches resting on pillars about a

The range of two storey buildings was erected on three sides of the cloister. The eastern wing, (Floor Plan 13 - 16) faced onto the main expanse of the Abbeypark, and contained four large rooms with a dormitory area on the floor above. The first room was the Chapter Room, where the Canons assembled several times a day to listen to readings from Sacred Scripture or to a chapter from their Rule – hence the name Chapter Room. (Floor Plan 16) The Prior would have addressed them on issues relating to their religious lives or to their work in the surrounding parishes. Meetings and discussions were also held here. The seventeenth-century addition of the oven, fireplace and chimney have altered the original design of the Chapter Room. A door led from this room to the covered Cloister and another to a smaller adjoining room, which had a window looking east.

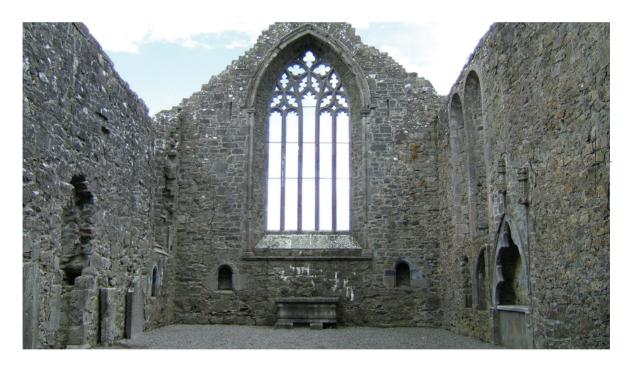
The Chancel

That portion of a church containing the high altar, which is normally reserved for the clergy, is called the chancel. This was the earliest part of the church buildings to be erected at Clontuskert, probably in the late 1100s. When the officers of the Board of Works commenced the archaeological excavations in 1970, many of notable features of the chancel in Clontuskert Priory had fallen into ruin. Most of the east gable had collapsed in 1918 and with it the

East Window. Luckily, almost all the stones of the window were found in the rubble of the collapsed wall. The wall was rebuilt and, fifty four years after its collapse, the magnificent east window was carefully restored to its former glory. This five-lancet window had replaced an earlier three-lancet window which was built in the late

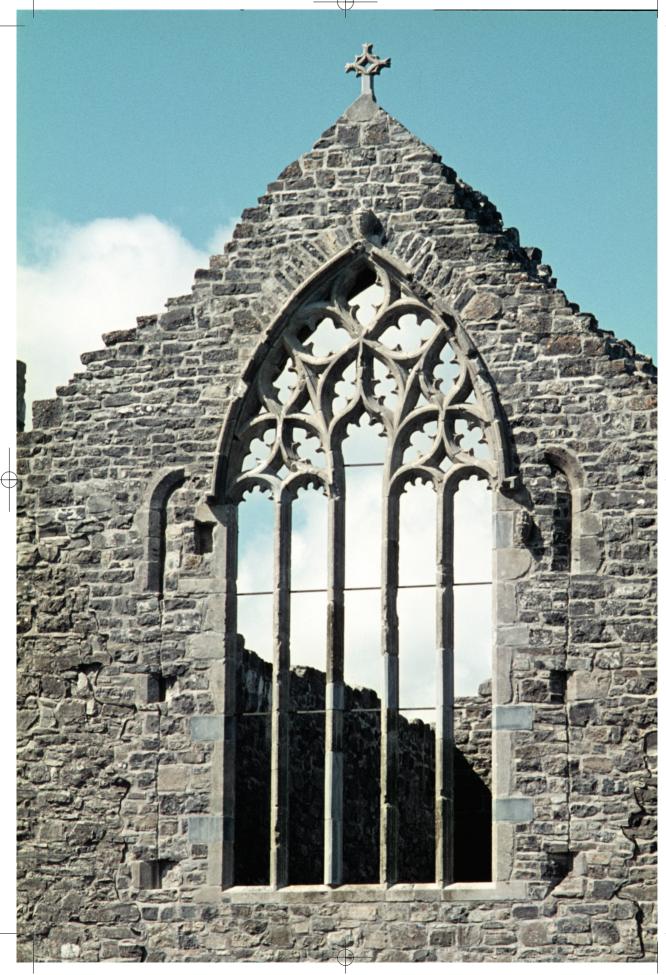
1200s. At the top of the central section or lancet there is an arrangement suggesting the five petals of a flower in bloom. The side lancets have a similar arrangement, this time with the three petals of a flower. Unlike many church windows, the central section of this window is higher than the side sections. Above the exterior point of the window is an interesting crowned or helmeted head. No details are available as to the person who may be represented by this sculpted figure.

The great East window was reassembled and rebuilt. Only two pieces of the original tracery could not be found and these were replaced with sawn limestone. A smaller window was

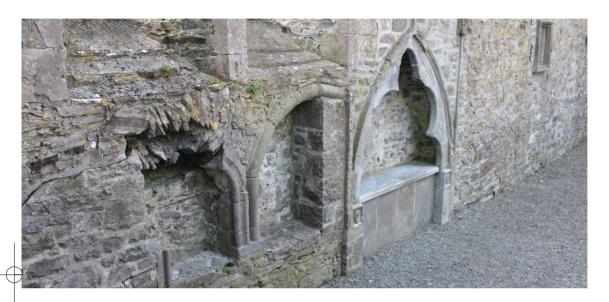
The other half of the main church building is the nave. This is where the faithful gathered for worship. A wall dividing chancel from nave was erected in 1637 as can be seen from the date over the

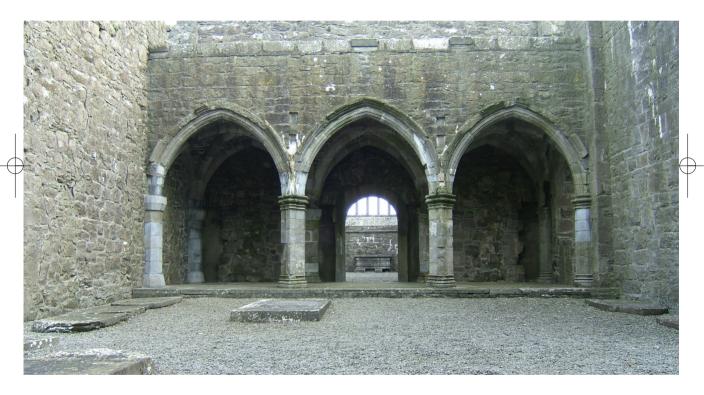
Rood screen, looking towards Chancel and East Window beyond.

dismantled when the dividing wall was built. Once again, during reconstruction work, the bulk of the structure was found at various locations on the site and faithfully restored. [Floor Plan 3] The screen is three bays in width across the body of the church and one bay from front to back. An overhead platform is supported by six beautiful arches. To appreciate the full beauty of the structure, the viewer must visualise it standing alone without the 1637 wall. It then becomes clear that the congregation could see all that was happening during ceremonies in the chancel.

The purpose of the rood screen was to emphasise the sacred nature of the chancel in the same way that the curtain of the Temple in Jerusalem separated the public area from the Holy of Holies. So that the congregation's view of the chancel would not be

obscured, entry to the platform over the rood screen was made from the outside by means of a wooden stairs. Statues were displayed and blessings were imparted from this elevated vantage point. A cross was displayed on the platform over the rood screen; hence its name, the word *rood* deriving from an old English word meaning *cross*.

The master mason responsible for carving and erecting the beautifully executed rood screen, carved his name, *Johes*, on the upper portion of the south west column. 'Johes' is the abbreviated version of Johannes, the latin word for John. It is interesting to note that he signed his name in a similar fashion on the traceried windows of the south transept of the Dominican friary at Portumna.

reassembled and replaced in the gable of the North Transept. Most of the pieces were located for this window. The stone- vaulted rood screen was reassembled and now stands in its original position. This is a very rare surviving feature in Irish monasteries. The cloister arcade was reconstructed. One and a half sides were totally reassembled, while another one and a half were partially reassembled. Washed pebbles were spread over areas which were originally roofed, while areas which were open to the sky were sown with grass.

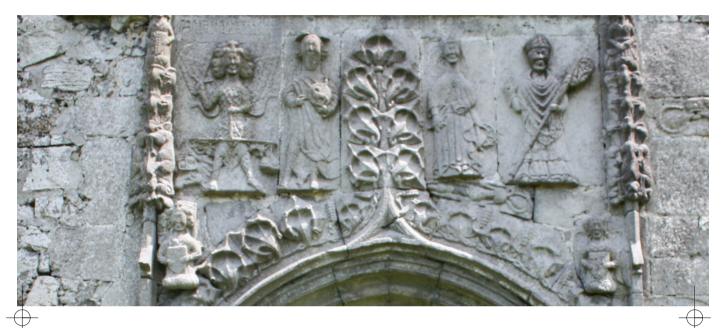
A frieze of four notable figures

The upper register of the doorway is most interesting. A tree grows from the highest point of the arch, dividing the four dominant figures at the top into two groups. The first figure from the left is a youthful-looking St. Michael the Archangel, holding the sword of retribution in his right hand and the scales in his left. Souls will be weighed in the scales of judgement and punished or rewarded accordingly. There is a touch of humour in the depiction of the characters in the balance-pans of the scales. In the pan on the

left, a devil with bat-like ears is hanging on to an unfortunate soul while another devil has the right-hand pan all to himself.

Beside St. Michael is the figure of John the Baptist. His role as the precursor of Christ is highlighted by the symbols in the carving. He is wearing a camel skin cloak with the hair next to his flesh, reminding us of his penitential sojourn in the desert. A disc in his hand bears a representation of the Agnus Dei, the Lamb of God.

On the other side of the central tree, the figure on the left is St. Catherine of Alexandria. She holds the sword of martyrdom in her hand. Her cloak is clasped in place by a typical Irish ring. She is easy to identify because of the partially hidden spiked wheel which was used in her torture and to which she was tied before being rolled downhill. Despite surviving this ordeal, she was later beheaded by a stroke of the sword. It is appropriate that she is of North African origin because of the Priory's connection with another native of that region, St. Augustine of Hippo.

There is some doubt as to the identity of the final figure in the group of four, a bishop holding his crozier. Some authorities suggest that it may be St. Brendan, the patron of Clonfert diocese, while others believe it may be St. Patrick. However, the most likely candidate is St. Augustine, the patron of the Priory. This belief is based on the strongly held local tradition. His memory was

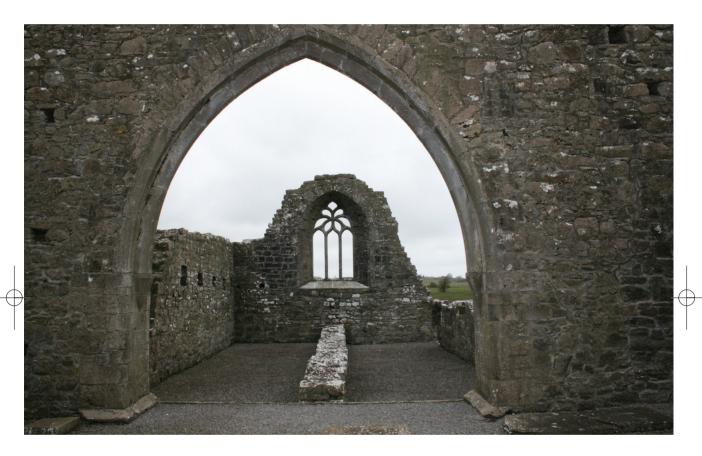
The North Transept.

A pointed arch stretches over the opening leading from the nave to the transept and there is a beautifully carved, three lancet window over the altar. The low wall stretching the length of the transept and dividing it into two segments, is a puzzling structure at first sight. It seems it was built at a much later date, possibly when the priory was in serious decline or when the religious had already left. The foundations were poor and were never meant to

A transept is an extension built at right angles to the nave of a church building. Such is the case in Clontuskert Priory, where a substantial extension is built on the northern wall of the nave. The North Transept was one of the latest additions to the priory, built in the late 1500s.

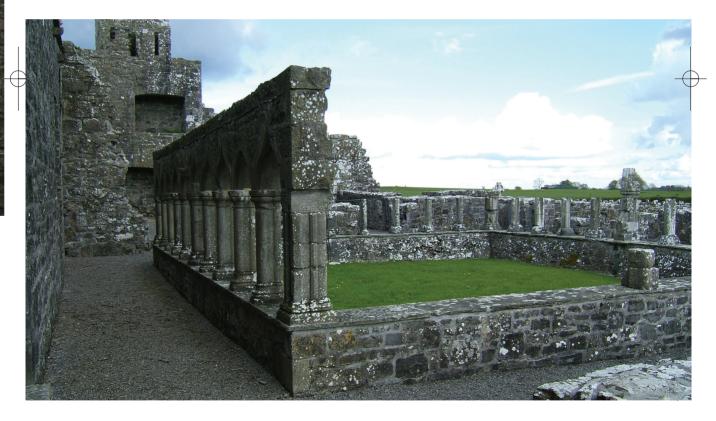
The Cloister Garth

metre apart and decorated with carved foliage or the occasional human or animal face.

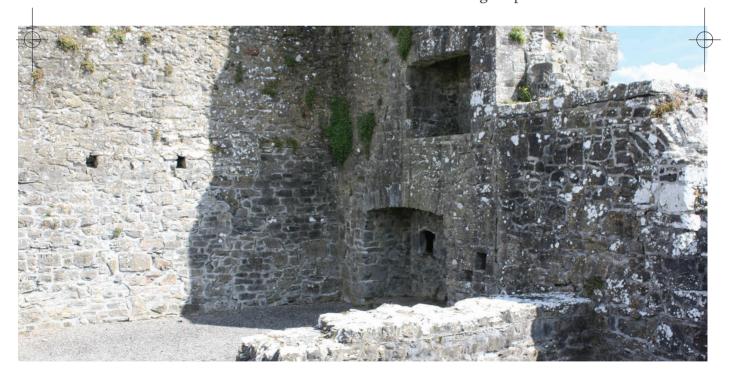
Chapter Room, fire-place with the later addition of a bake oven

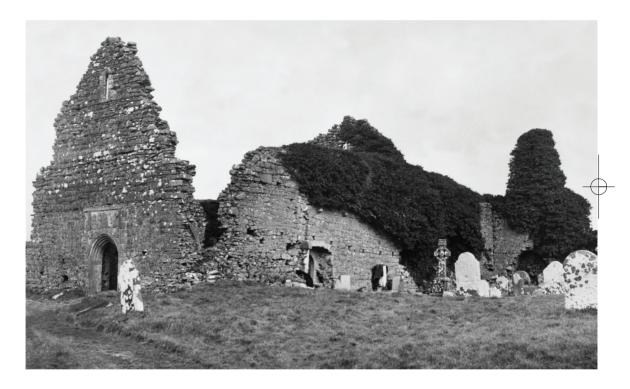
condition and when taken into State care, the Priory had reached a stage of near collapse. Thankfully this collapse did not happen, due to the fact that restoration work had commenced, preventing the final disintegration of the structure. An enormous amount of carved stone lay loose around the site before conservation work commenced. Some carved stones had been used as grave markers, and others had been used in the construction of walls in the surrounding district.

Ruins of Priory - 1950s

Work started on November 27<sup>th</sup> 1970. A huge task faced the architectural team under the direction of Thomas Fanning. It was proposed to repair the structure, to reassemble the vaulted rood screen, the east window and part of the cloister arcade.

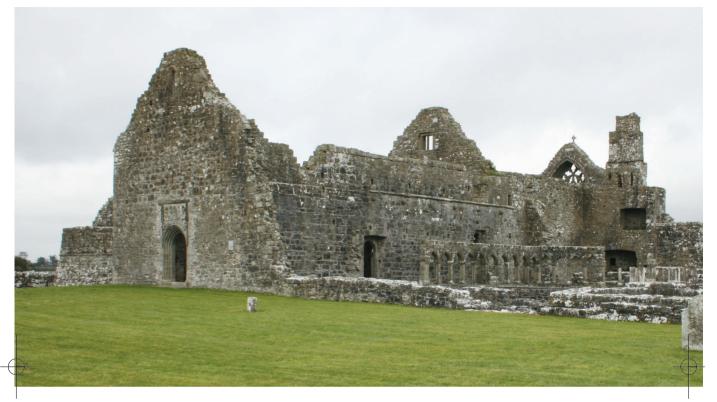
The Priory of St. Mary at Clontuskert

archaeological content of the areas which would be affected by the conservation work, and to uncover whatever foundations and artifacts were lying beneath the rubble. Work began in June 1971 and continued for four months.

The badly decayed walls were extensively repaired. The project resembled the assembly of a giant jigsaw puzzle. Carved stones were carefully sorted and laid out in groups according to their historical period and architectural style. These groups were further examined to see what could be positively identified and replaced in their correct position.
